## CORROSION OF A CHIMNEY LINER OPERATED FOR 130,000 HOURS

M. Gwoździk

Czestochowa University of Technology, Faculty of Production Engineering and Materials Technology,  
Department of Materials Engineering, Czestochowa, Poland

### Abstract

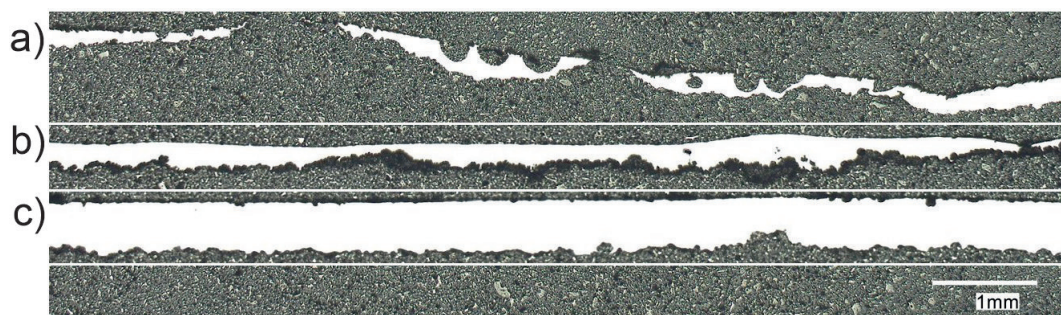
The obtained test results of the chimney liner showed that, depending on its location, there is a differentiated degradation. As shown in Figure 3, the lowest degree of degradation is characterized by the chimney liner closest to the inlet to the furnace. Going up, i.e. at the height of 8 meters from the inlet, the

Figure 3. Differentiated degradation of the chimney liner: (a) 12m from the ground, (b) 8m from the ground, (c) 4m from the ground

degradation is already progressing significantly. Directly at the outlet from the chimney, i.e. at a height of 12 meters from the ground, the complete exploitation of the tested chimney liner is visible for the most part.

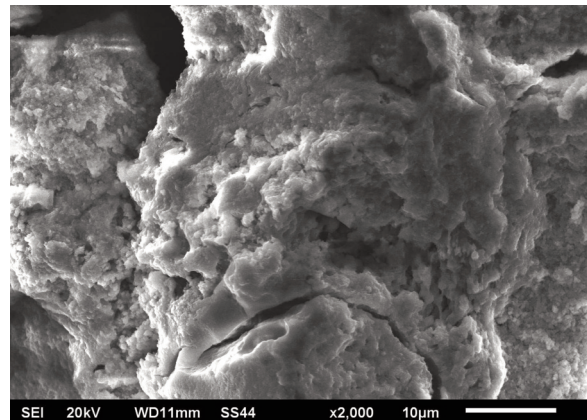
cracks (Fig. 6), which would indicate a significant post-mining degradation of the above-mentioned structure.

Figure 6. Cracks in the deposits on the inside wall of the chimney liner

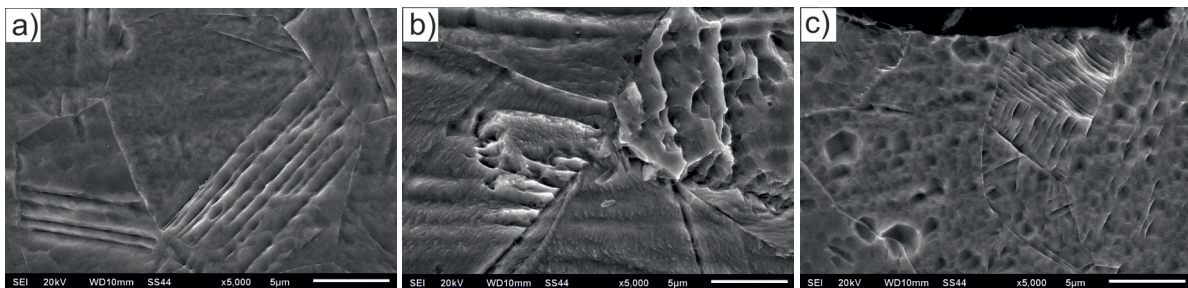
A varied structure of the chimney liner was observed depending on its location in the chimney. Near the inlet to the furnace, polygonal austenite grains with formed twins and carbide precipitates are observed (Fig. 4a). The addition of 8% nickel in steel with a concentration of 18% chromium provides corrosion-resistant steels with a durable austenitic structure. Austenitic steels with the fcc crystallographic structure (wall centered) are used as materials for storage and transport in cryogenic conditions, e.g. due to their high corrosion resistance [22]. As it moves away from the inlet, a progressive degradation of the structure is observed. The twins are gradually being destroyed. Craters can be seen forming. In addition, there are visible empty places after carbide precipitations (Fig. 4b). The formation of craters on this type of steel was also observed by Tian et al. [23]. They researched investigated the effect of stress on the microstructure evolution of 316L SS and 304 SS steels subjected to cavitation erosion and cavitation erosion-corrosion. Figure 4c, on the other hand, shows the structure of the tested chimney liner directly from the side of the flue gas outlet. In places, complete degradation of the structure is visible. The chimney liner in this area was locally damaged over the entire thickness of the sheet metal wall.

Figure 4. Chimney liner structure: (a) 4m from the ground, (b) 8m from the ground, (c) 12m from the ground

1. The structure of the chimney liner changed depending on its location. Directly near the chimney outlet, the structure is completely degraded. The chimney liner in this place was completely destroyed over the entire cross-section.

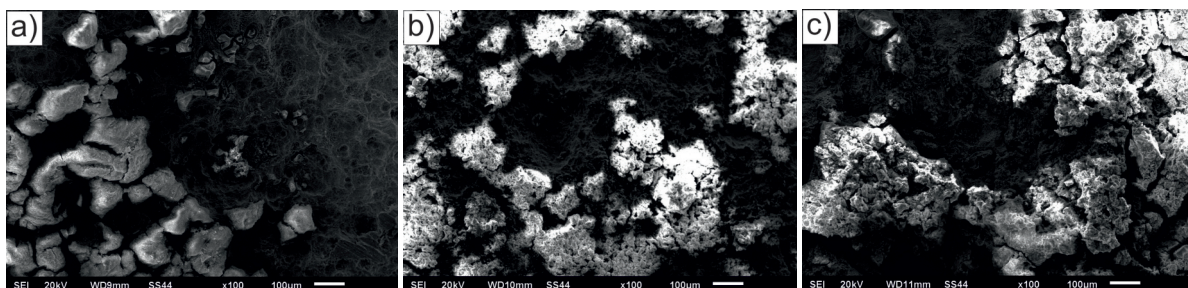
The observations of the outer and inner (Fig. 5) walls of the chimney insert showed a varied amount of deposits, not only depending on the side of their location, but also on the height of the insert. The microscopic observations show that the inner side of the chimney liner was degraded regardless of where the sample was taken. In all three cases, the surface of the top layer was damaged (Fig. 5). A layer of sediments and progressing corrosion pits are visible. The obtained results indicate that the sample taken directly at the chimney outlet is characterized by the highest degree of degradation. Only a small amount of sediment can be observed on this sample, the rest of the area is just pits. In each of the analyzed cases, the deposits formed show numerous

Figure 5. The inner side of the chimney liner wall: (a) 12m from the ground, (b) 8m from the ground, (c) 4m from the ground

2. The inner side of the chimney liner has degraded regardless of where the material was taken.

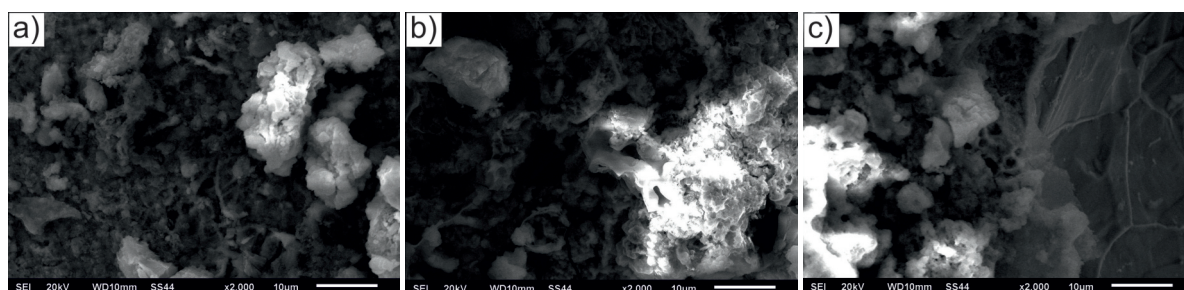
A different situation was observed for the external side. From this side, no corrosion pits were observed on the surface at a distance of 4 meters from the ground (Fig. 7a). The pits appear only in the upper part of the chimney liner (Fig. 7b, c). In Fig. 7b, occasional pits are visible. What is important, however, is that at 8 meters in the outer layer of sediment, cracks begin to appear. Observations of the external side of the chimney liner directly from the flue gas outlet have already shown quite numerous presence of pits. In Fig. 7c, from the left side, a pit extending deep into the structure is visible. The irregular nature of the corrosion damage on the surface indicates pitting/crevice corrosion. A similar character of corrosion was observed in [24]. According to the literature [25] austenitic stainless steels type 316, 317 and 904L are subject to pitting and crevice corrosion. Moreover, a similar course of cracks was observed in [24]. SEM micrographs of the chimney liner surface at lower magnification show several depressions, and at higher magnification show small cracks in a wide and shallow pit. The condensation of harmful combustion products takes place in the upper part of the chimney and thus the chimney liner. In the lower parts of the chimney there are high temperatures, i.e. higher than the dew point of the oxidizing gases. As a result, the gases accumulate in the upper parts of the chimney, where the temperature drops below the dew point. In these parts, saturated condensate corrodes the chimney by accumulating soot on the walls of the chimney. The accumulation of soot, in turn, may reduce the cross-

section of the chimney, which in turn may lead to the phenomenon of saturation of the lower parts of the chimney with condensate [24].

**Figure 7.** The outer side of the chimney liner wall: (a) 4m from the ground, (b) 8m from the ground, (c) 12m from the ground

3. The outer side of the chimney liner shows significant degradation only directly from the chimney outlet.

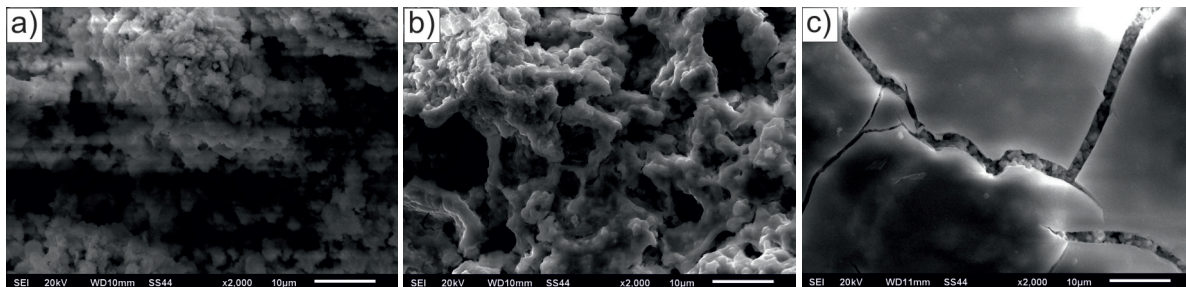
Sediments separated from the inside were characterized in terms of morphology. Three different types of these deposits were observed. The first one has the character of fine, strongly compact structures (Fig. 8a). The second type is an irregular structure. Settlements of this nature form agglomerations in places resembling the so-called honeycomb (Fig. 8b). The third type of sediment is characterized by a completely different structure. In this case, fine sphere-like deposits are placed under a compact smooth surface. To a large extent, this surface is cracked (Fig. 8c). The analysis of the chemical composition of isolated sediments (Table 2) showed that the first type is characterized by the presence of such elements as O, Fe, Cr, C, Cl, S, and Ni. In the second type, the presence of silicon and potassium was additionally found. The third type, in addition to the above-mentioned elements, additionally contained calcium and manganese, but no carbon was found in its composition.

**Figure 8.** Isolated deposits: (a) I type, (b) II type, (c) III type**Table 2.** Chemical composition of isolated sediments

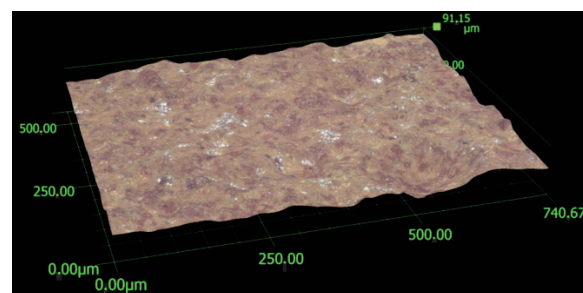
The obtained roughness measurement results (Fig. 9, Table 3) for the inner side of the chimney liner showed the lowest value of the parameter  $S_a = 10.13\mu\text{m}$  for the sample placed closest to the furnace. The surface development directly at the outlet was much greater with the arithmetic mean height being  $23.32\mu\text{m}$ . Roughness measurements are very helpful in determining the roughness of deposits/oxides [27]. A similar increase was observed for the  $S_z$  parameter, where it was  $91.15\mu\text{m}$ ,  $148.59\mu\text{m}$ , and  $160.66\mu\text{m}$ , respectively. For the outside of the chimney liner, the arithmetic mean height was  $1.96\mu\text{m}$  at a height of four meters. However, a significant increase of this parameter to  $31.25\mu\text{m}$  was observed directly at the chimney outlet. Such high roughness is due to the fact that the layer of sediments has largely fallen away in the places where the pits are located. The value of the  $S_{sk}$  parameter is closest to zero for the sample that was taken from a height of eight meters both from the inside and outside of the chimney liner, which would mean that the height distribution is symmetrical to the reference plane. In other cases, the height distribution is slanted up or down relative to the reference plane. The obtained measurement results indicate that for the sample from the inside at a height of 8m, the distribution of the height of the surface irregularities is

the closest to the normal distribution, which is indicated by the  $S_{ku}$  parameter.

**Figure 9.** An example 3d image - the inside of the wall of the chimney insert
