## ANALYSIS OF PREMATURE CRACKING CAUSES OF ASTM A213-T12 SUPERHEATER TUBE

The failure behavior of the superheater tube made of ASTM A213-T12 steel was studied. The microstructure and hardness at different positions of the tube, the element distribution at the crack location, and the morphology and phase composition of the corrosion layer were analyzed by optical microscopy (OM), microhardness tester, scanning electron microscopy (SEM), and X-ray diffractometer (XRD). The results show that the pearlite undergoes spheroidization at the fracture site and the hardness is significantly reduced compared to the normal position. The failure is closely linked to corrosion and creep. On the one hand, sulfur corrosion and oxidation corrosion occur on the outer layer of the superheater tube, which greatly reduces the thickness of the tube. On the other hand, the creep resistance of the tube is significantly reduced by the thinning. There are numerous creep voids in the microstructure at the failure site. Meanwhile, oxygen can diffuse into the voids to promote oxidation corrosion.

This paper explores a boiler superheater tube cracking incident that occurred in a certain thermal power plant,

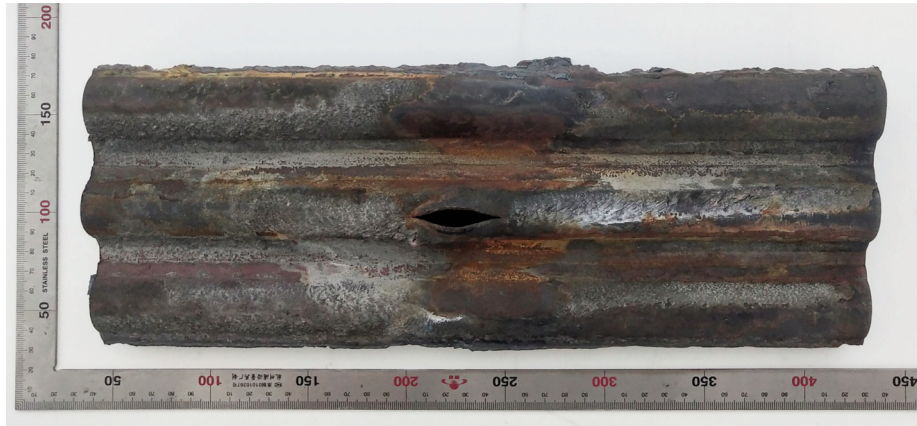
The chemical composition (wt.%) of the superheater tube was tested, and the detailed values were shown in Table 1. The test result was within the range of T12 steel composition in ASTM A213/A213M-23 standard [14]. Based on the service conditions of the superheater tube and the measured chemical composition result, it is determined that the material of the superheater tube is ASTM A213-T12 steel. Fig. 1 shows the damaged superheater tube received for failure analysis. It can be observed from the figure that there is a large amount of rust on the outside of the superheater tube, and severe deformation occurs at the cracking position. The failure crack is about 50 millimeters (mm) long and appears in the shape of a fish beak. The thickness of the tube is measured along the direction of tube cracking, from the highest prominent position of the burst tube to the normal position of the tube. The test interval is about 5 mm, and the thickness values are 2.88, 3.92, 4.74, 5.46, 5.66, 6.10 mm, respectively. The thickness measurement of the tube revealed that the thinnest thickness at the failure position was 2.88 mm, while the thickness at the normal position was 6.10 mm, as shown in Fig. 2. Visual inspection confirmed corrosion and thinning of the superheater tube.

**Figure 1.** The damaged superheater tube received for failure analysis

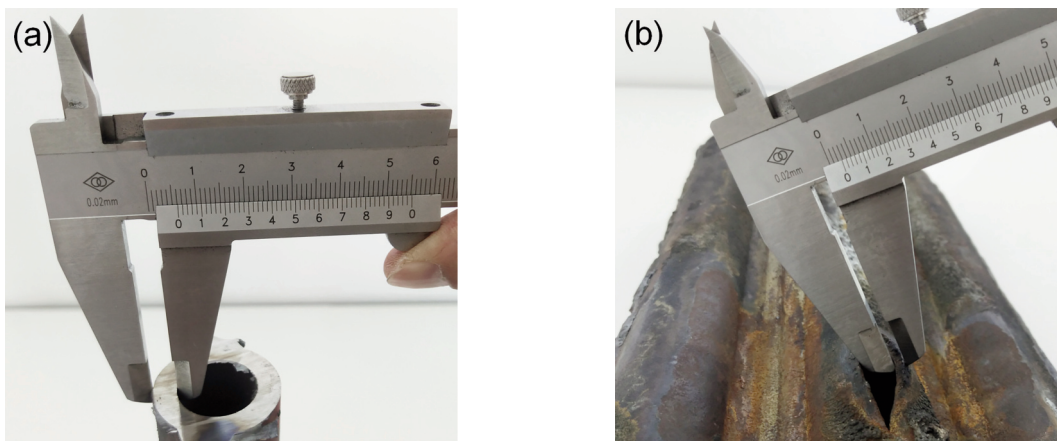
**Figure 2.** Thickness measurement of the superheater tube: (a) normal position, (b) failure position

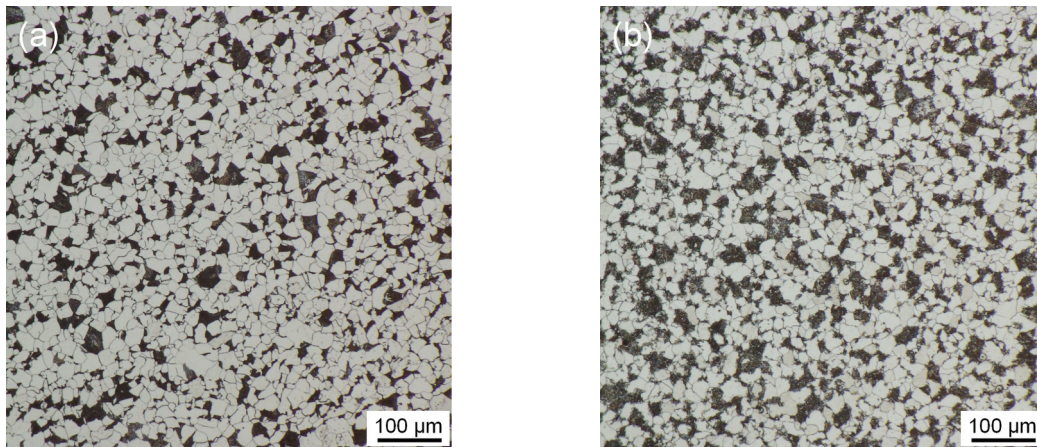
that the microstructures are composed of white ferrite and black pearlite. The difference is that the edges and corners of the pearlite at the normal position are neat and clear, while those in the failed position become blurry and show burrs, and their colors also become lighter. This indicates that the pearlite at the failure position has undergone spheroidization. The average microhardness test results for the normal and failure positions of the superheater tube are 170 and 134 HV, respectively, which illustrates that the thinning area has lower hardness. The decrease in hardness can be explained by the spheroidization of pearlite [15].

**Figure 3.** OM images of the superheater tube: (a) normal position, (b) failure position

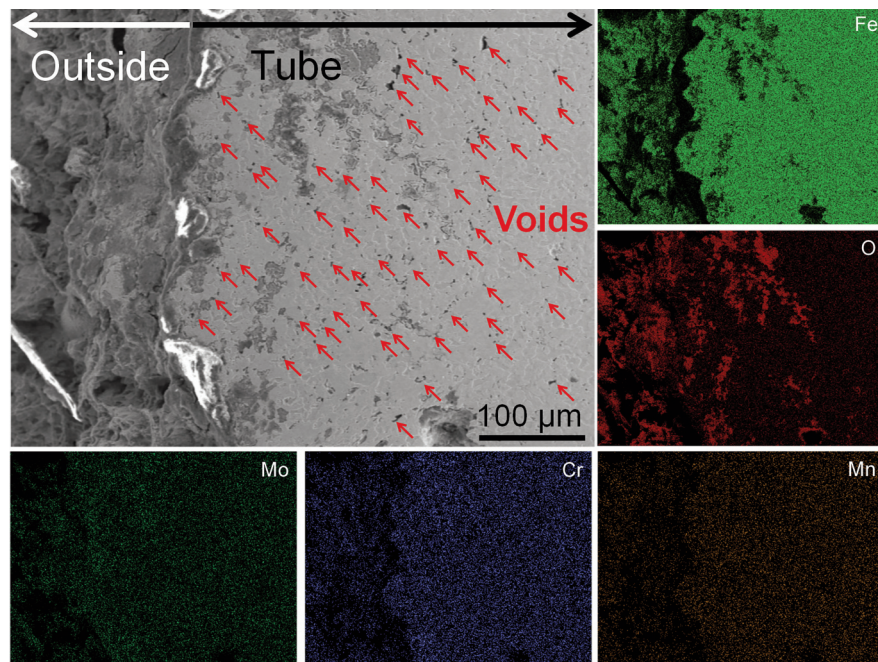
Fig. 4 displays the cross-section's SEM and EDS mapping analysis near the outside of the superheater tube failure position. It can be observed that there are a large number of voids in the microstructure of the

tube (indicated by the small red arrow). At the same time, there are also some micro-cracks. EDS detection confirmed the presence of O in the voids and cracks, further proving the existence of oxidation corrosion. This indicates that cracks and voids create some open channels below the surface for O diffusion. O element diffuses into the interior of the substrate through these open channels and reacts with iron, promoting the occurrence of tube oxidation corrosion.

**Figure 4.** SEM and EDS mapping analysis of the cross-section near the outside of the superheater tube failure position

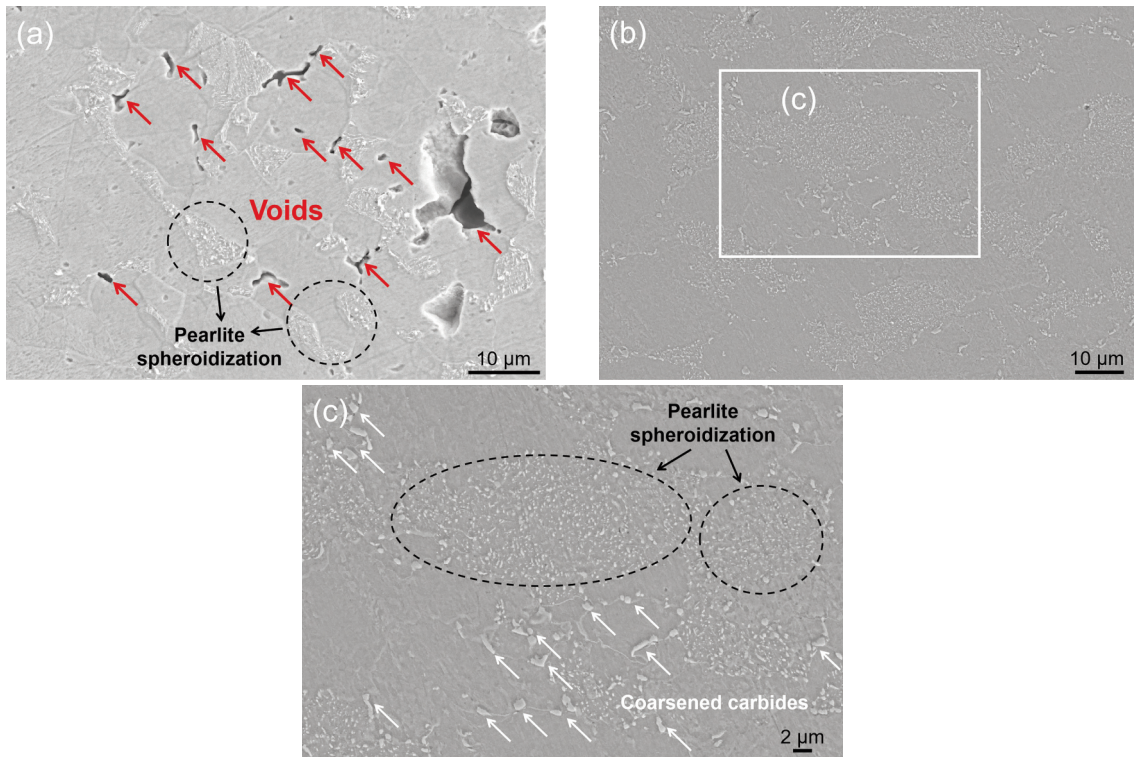
In order to observe the microstructure characteristics and voids distribution of the failed tube more clearly, a high magnification SEM analysis was performed on the failure position, as illustrated in Fig. 5. The presence of voids in the microstructure was reconfirmed (as indicated by the thick red arrow in Fig. 5(a)). Multiple voids with different shapes can be

found in the microstructure. There are elongated voids at grain boundaries, small circular voids within grains, and large voids that have already developed. Among them, the voids at grain boundaries account for the vast majority. It should be pointed out that the coalescence of adjacent voids will transform into micro-cracks [16, 17]. Meanwhile, it was further confirmed that the microstructure underwent pearlite spheroidization, as shown by the circles in Figs. 5(a), 5(b) and 5(c). The spheroidization of pearlite and the formation of micro-voids at grain boundaries or within grains both confirm the existence of creep in the structure [18]. In addition, coarsened precipitates can also be observed in the microstructure (as shown by the white arrow in Fig. 5 (c)). This further confirms the occurrence of creep [19, 20]. Therefore, combined

with the deformation at the crack of the superheater tube, the presence of voids, pearlite spheroidization and coarsened precipitates in the microstructure, it can be proved that the tube has undergone creep.

**Figure 5.** High-magnification SEM image at the failure position of the superheater tube: (a) adjacent to the location of the crack, (b) position closer to the substrate than fig. 5(a) (slightly farther from the crack than shown in Fig. 5 (a)), (c) enlargement of frame position in fig. 5(b)

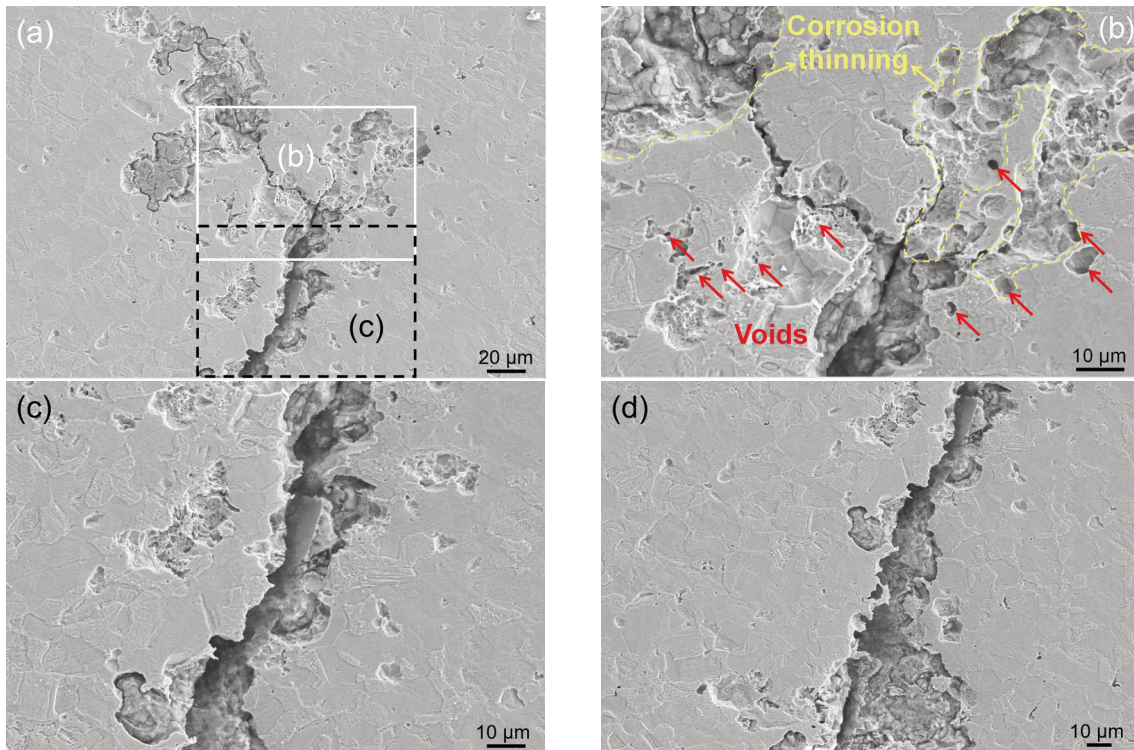
After repeated cleaning of the failure position, the cleaning morphology of cracks in the microstructure was given, as depicted in Fig. 6. It is interesting that although most of the voids in the microstructure are distributed at grain boundaries (as presented in Fig. 5), the cracks do not exhibit intergranular fracture, but rather a transgranular manner, as shown in Fig. 6(d). The macroscopic plastic deformation at the crack of the superheater tube in Fig. 2(b) can also confirm the occurrence of transgranular fracture. Zhou et al. [21] also found a similar situation in the creep test of ferritic heat-resistant steel and confirmed that the

**Figure 6.** SEM image of crack at the failure position of the superheater tube: (a) morphology near crack tip, (b) enlargement of the solid box position in fig. 6(a), (c) enlargement of the dashed box position in fig. 6(a), (d) extension of crack

voids do not extend along the grain boundaries, but across them. In addition, the voids inside the grains preferentially form at the positions where pearlite spheroidization occurs, and the strength of these areas is not as strong as that of the grain boundaries, which can promote transgranular fracture. The presence of corrosion thinning can also be observed in Fig. 6(b) (indicated by the small yellow arrow), accompanied by the appearance of creep voids in the area where thinning interacts with cracks (indicated by the red thick arrow).

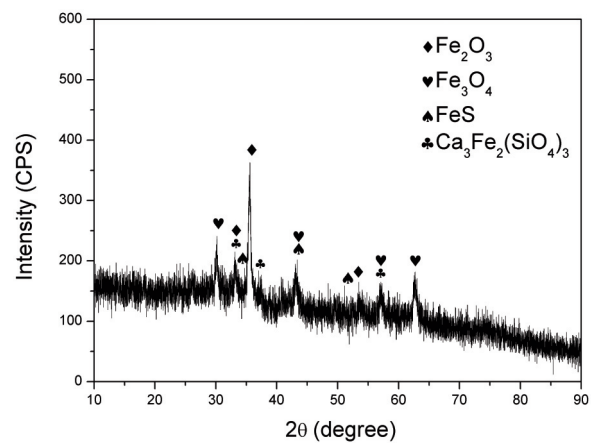
The corrosion products at the failure position of the superheater tube were peeled off and ground into powder, and the phase compositions were analyzed through XRD. Fig. 8 shows the XRD detection

results. It can be observed that corrosion products are composed of  $\text{Fe}_2\text{O}_3$ ,  $\text{Fe}_3\text{O}_4$ ,  $\text{FeS}$  and  $\text{Ca}_3\text{Fe}_2(\text{SiO}_4)_3$ , which is in agreement with the element distribution results of EDS analysis in Fig. 7. The presence of  $\text{FeS}$ , combined with the S in the corroded layer shown in Fig. 7, proves that the superheater tube has undergone sulfurization corrosion. It can be observed from Fig. 8 that there is amorphization in the XRD analysis of corrosion products. This can be explained by the fact that during the corrosion process, although iron oxides and iron sulfide are formed, the supersaturation required to form crystals is limited. In addition, corrosion reactions occur on the surface, and temperature and pressure conditions are not conducive to crystal formation.

Figure 8. XRD analysis of corrosion products powder

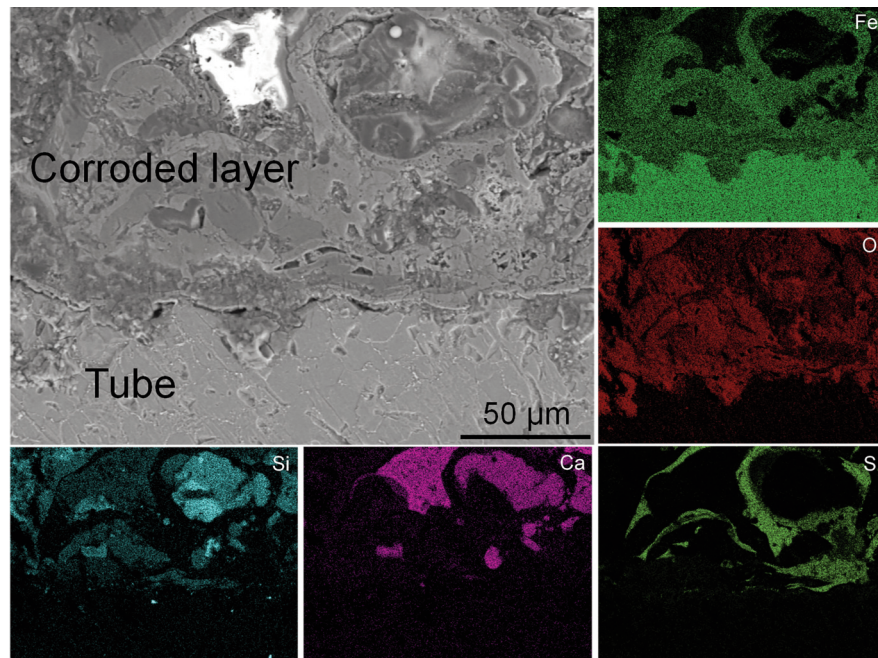
Fig. 7 shows the SEM and EDS mapping analysis of the corrosion layer at the failure position of the superheater tube. It was found that the corroded layer is rich in Fe, O, Si, Ca, and S elements, and the matrix is rich in Fe element. In addition, O element was found near the surface layer inside the matrix, indicating the diffusion of O into the matrix, which is consistent with the phenomenon observed in Fig. 4. The presence of S element is related to the contact between the superheater tube and the flue gas or the deposition of coal ash on the superheater tube. No S element was found in the matrix, indicating that S did not diffuse into the matrix, which may be due to the low S content in the flue gas or coal ash.

Figure 7. SEM and EDS mapping analysis of the corroded layer at the failure position of superheater tube
