## CORROSION OF A CHIMNEY LINER OPERATED FOR 130,000 HOURS

M. Gwoździk

Czestochowa University of Technology, Faculty of Production Engineering and Materials Technology,  
Department of Materials Engineering, Czestochowa, Poland

### Abstract

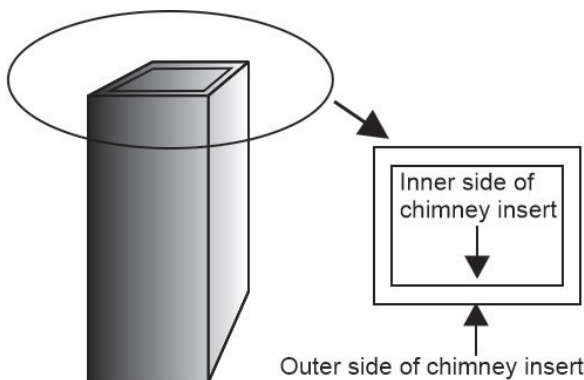
Figure 1. Chimney insert - positions of the samples used for microstructure analyses

tested at the height (counting from the bottom) of 4m, 8m and 12m. Coal with a grain size of 5–21mm was analyzed. The bottom ash consisted of both loose ash and a mass of glassy sintered ash, the so-called slag.

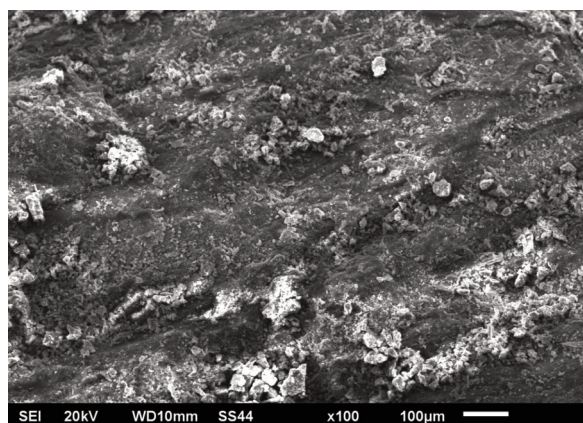
The hard coal used for combustion contained in its chemical composition, apart from organic substances that form the basic composition of coal, such as: carbon, hydrogen, oxygen, nitrogen, sulfur, also impurities in the form of ash based on the following elements: Al, Si, K, Ca, Fe. These elements are related to in oxides such as:  $Al_2O_3$ ,  $Fe_2O_3$ ,  $SiO_2$ ,  $CaO$ ,  $K_2O$ . According to the literature [19], the main elements of carbon are: C, H, O, N and S, where the relative proportion of C increases as the magma intrusion distance increases, whereas the residual elements, such as H, O, N and S, show an opposite tendency [20]. The sulphide minerals found in coal are mainly pyrite [21]. A lower share of  $SiO_2$  oxides in coal compared to  $Al_2O_3$  was observed by Ikeh et al. in paper [21]. An example image of coal topography used for combustion is shown in Figure 2.

Figure 2. Carbon surface

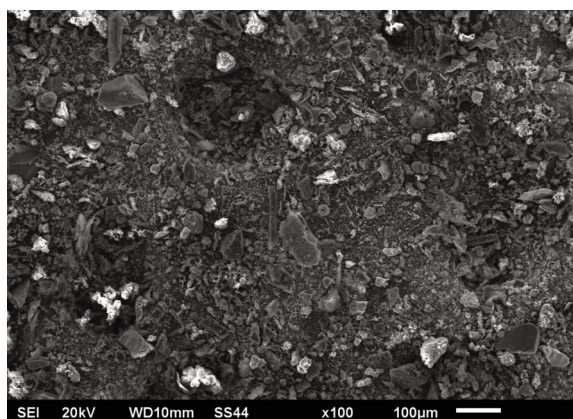
The test results obtained from the bottom ash showed (Fig. 10, Table 4) that it is characterized by a significantly lower sulfur content compared to the sludge from the chimney liner. This statement was confirmed in [6]. Researchers found that boiler deposits are characterized by a much higher sulfur content compared to furnace ash [6]. As the tests showed, no sulfur was detected in the burnt coal (Table 5). The structure of burnt coal is shown in Figure 11. Observations of coal fly ash using a scanning electron microscope were also carried out by Yu et al. [28]. As a result of coal combustion, a high ash content is obtained [29]. According to the literature, samples taken from coal were characterized by high sulfur content, 2.16% and 2.76%, respectively [6]. The ash samples were also characterized by a high content of sulfur from 2.24 to 3.11% and a relatively high content of unburnt carbon

**Figure 10.** Combustion ash

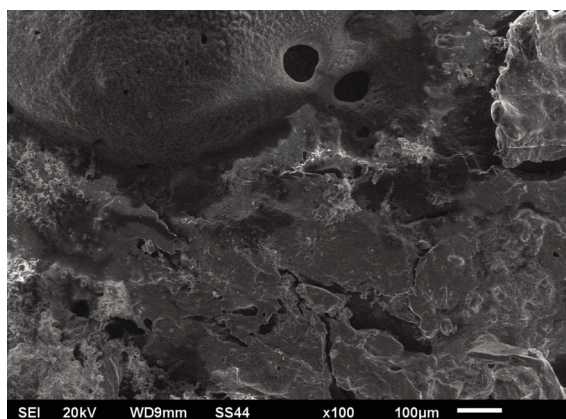
**Figure 11.** Burned coal**Table 4.** Chemical composition of combustion ash
